Verifone Petro Software Release Notes

Verifone Commander

Base Version	53.40.00
Distribution Versions	VAPS 1.12.40 Production Release
Release Date	January 4, 2023
Publication Date	January 4, 2023

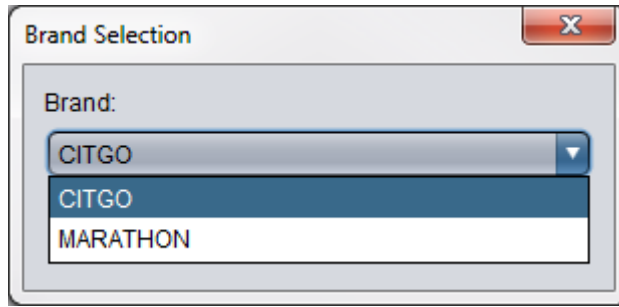
During the software installation, the system prompts for Brand Selection. Choose from the dropdown menu and then click OK.

After installation, see the Help menu and the About to check the Brand selection.
